Characterization of Two 120-mm Primers – the M129 and M125

by Stephen L. Howard and Anthony W. Williams

ARL-TR-4346

December 2007

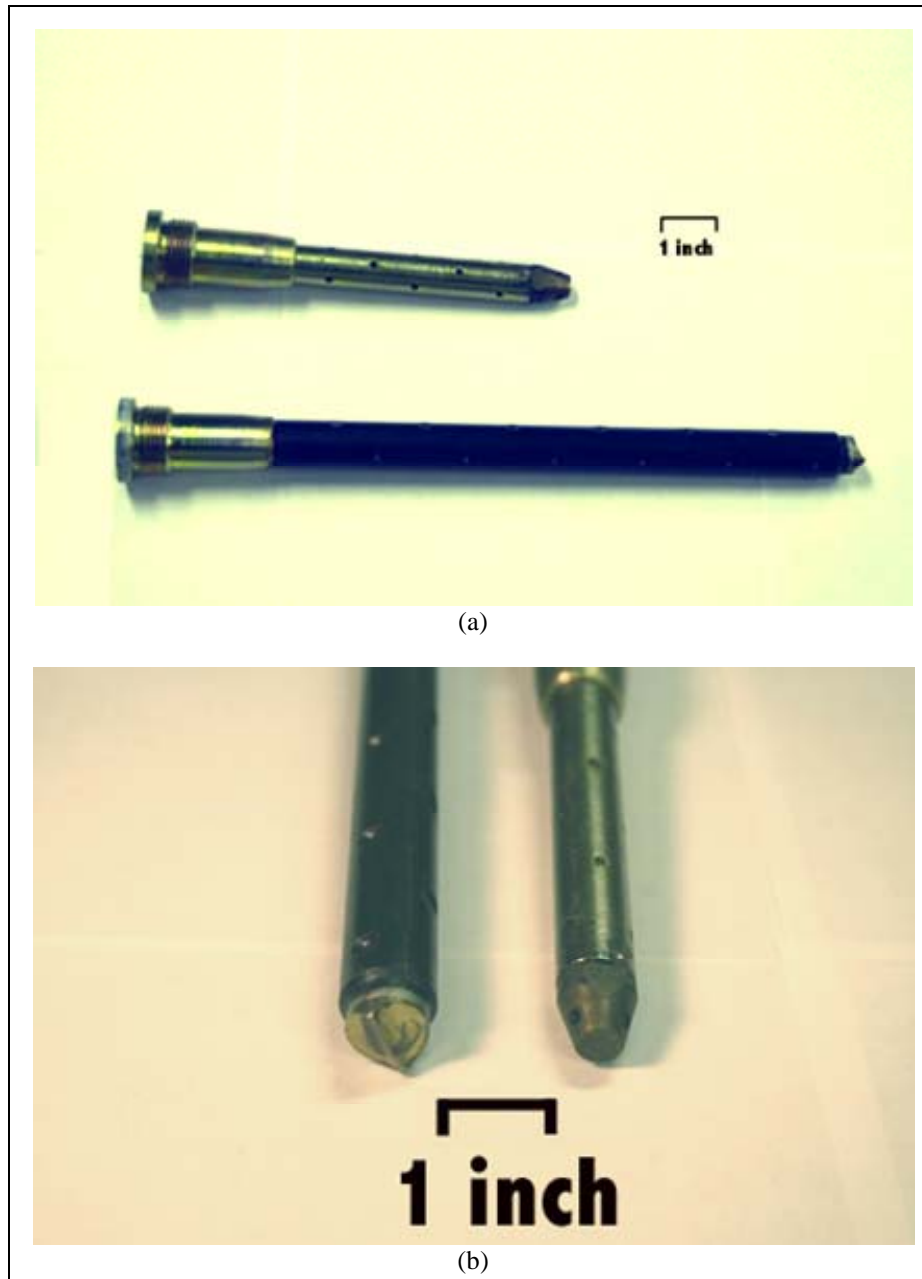
Figure 1. Photographs of (a) M129 (taper tip) and (b) M125 (black rubber coated) primers.

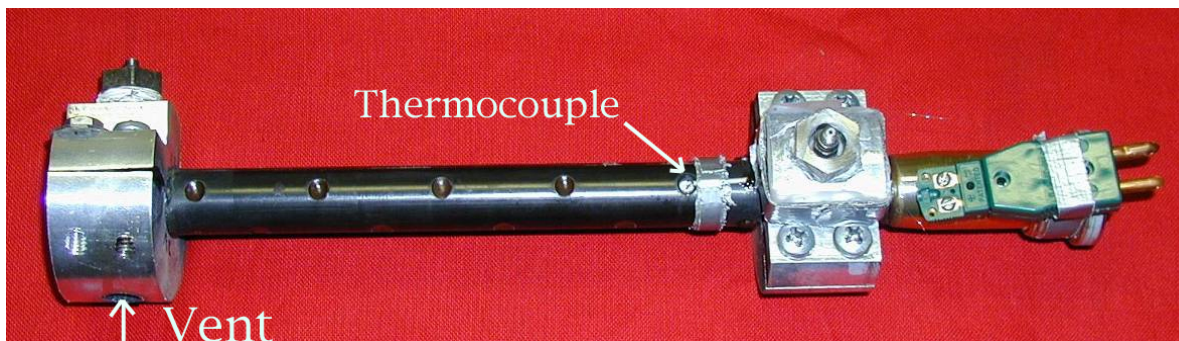
Figure 2. Photograph of M125 primer with pressure clamps (note vent hole on bottom of left clamp) and thermocouple in place.

Since the measurement of an object can change its properties, pains were taken to reduce the impact of the act of measuring the temperatures and pressures of the gases that these primers produced. For example, the clamps for holding the pressure transducers in place were designed to only cover and seal one vent hole (see figures 2 and 3). The other venting holes in the clamp were designed so as to minimize pressure perturbations in the venting jet. With pressure measurement desired at the base of the primer and at the tip, this measurement necessitated two vent holes to be covered (for the M125 primer, this number was 2 out of 24, and for the M129, 2 out of 18). Other studies may have had designs for the clamps that possibly covered other vent holes (or impaired the venting) at the same axial position (8–10). It should be remembered that properties of a gas or a particle-laden gas through a vent can be strongly influenced by the backing pressure into which it is vented. Such properties include velocity, expansion radius, residual pressure, and temperature. Therefore, the vent in the clamp must take such variables into account in its design.

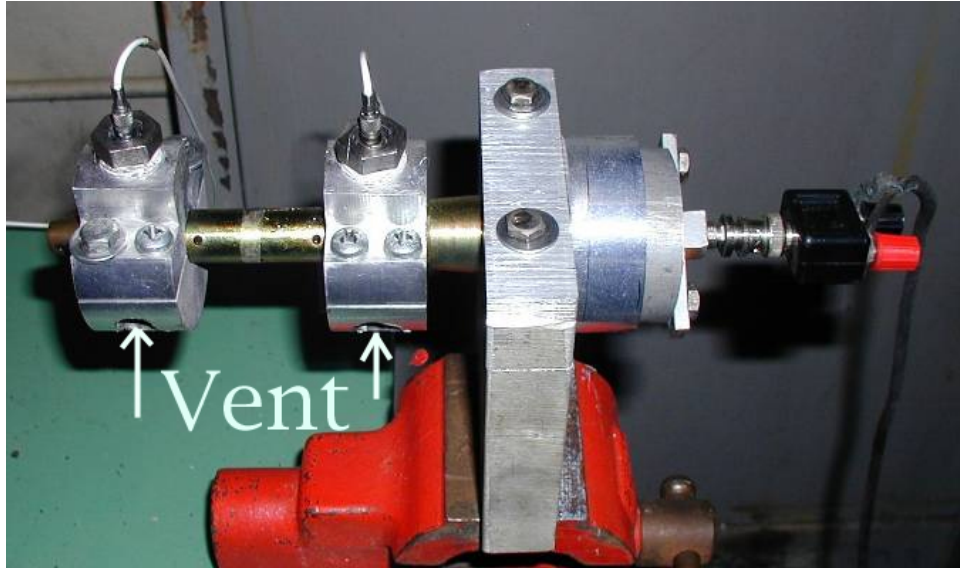
Figure 3. Photograph of M129 primer held in fixture with pressure clamps in place (note one of two vents on bottom of each clamp).

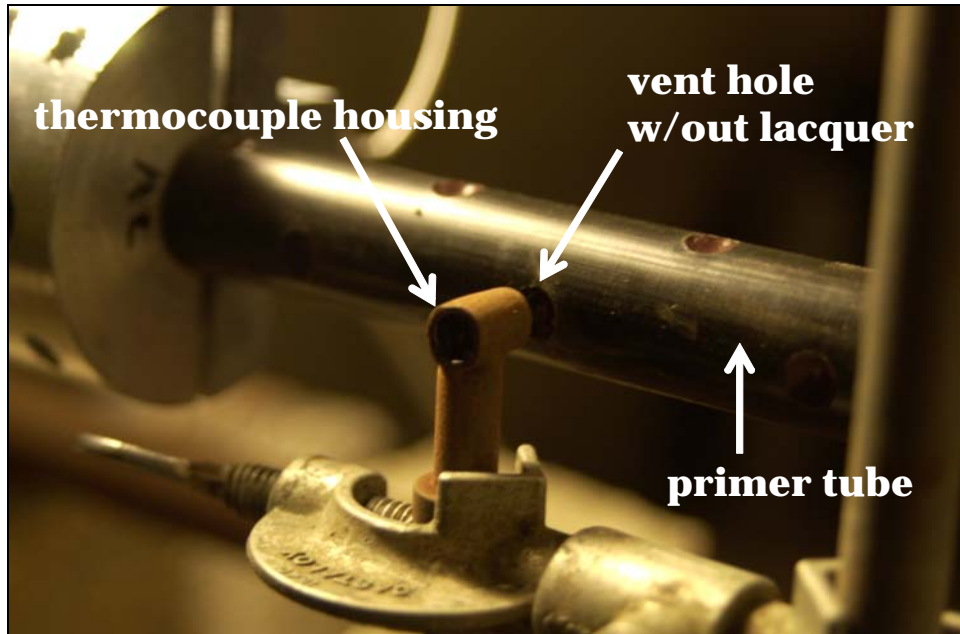
Figure 4. Photograph of a 3-mil thermocouple inside a planar wave thermocouple holder near vent hole of an M125 primer.

A couple of placement methods for the thermocouple were tried (see figures 4 and 5). Previous work with planar ignition waves in solid propellant beds used a holder (figure 4) that contained the thermocouple for protection and to maintain laminar flow past the thermocouple (11). This holder was placed next to the primer tube over the top of an opened vent hole (with paper liner punctured to allow early gases to be detected) at a distance of ~6 or 14 mm from the primer. The larger distance was chosen in an attempt to protect the thermocouple (early tests at 6 mm resulted in severed thermocouple wires), but it worked about as well as the 6-mm distance in this holder. It was later found upon examining the high-speed video that large chunks of material were ejected from the vent hole and so a fine-wire thermocouple stretched across the vent hole would

not likely survive. The thermocouple wire diameters used included 1 mil ($25\text{ }\mu\text{m}$), 2 mil ($51\text{ }\mu\text{m}$), and 3 mil ($76\text{ }\mu\text{m}$). The lag times for thermocouples were estimated from previous work to be less than 0.3, 1, and 2 ms, respectively (11). Since the thermocouples did not survive well, a second placement method was developed.

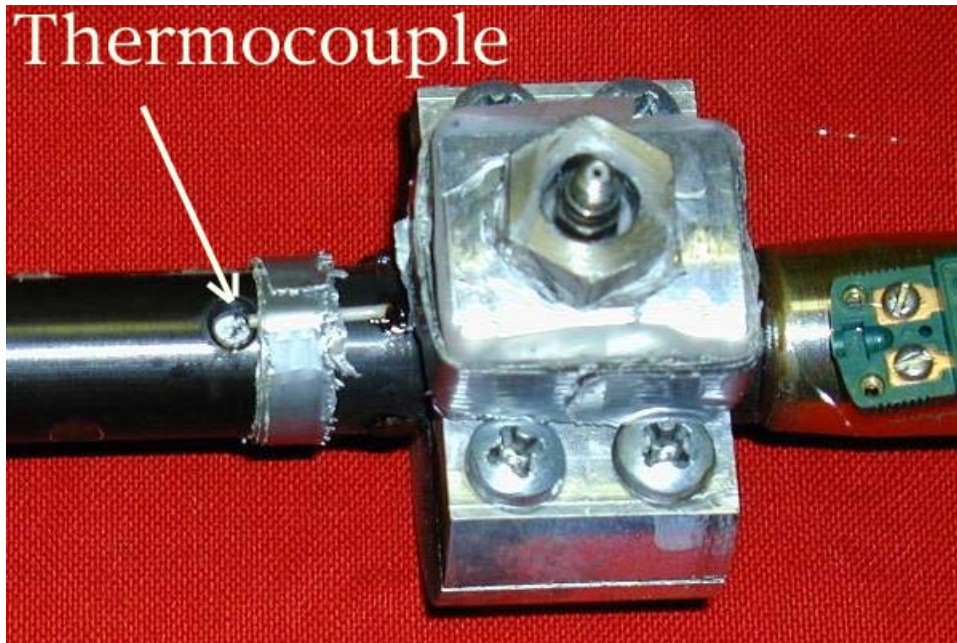
Figure 5. Photograph of a 2-mil thermocouple in a ceramic tube support taped next to a vent hole on an M125 primer.

In the second method, the two wires of the thermocouple were threaded through a small section of a two-holed ceramic tube leaving the thermocouple junction a small distance from the tube end. The tube was taped securely to the primer tube with the thermocouple junction (which was slightly separated from the end of the ceramic tube) slightly protruding into the region of the vent hole where the venting jet would be located (figure 5). The ceramic tube was held in place by several laps of a fiber-reinforced tape with sufficient strength to hold the ceramic tube securely in position during the entire venting process.

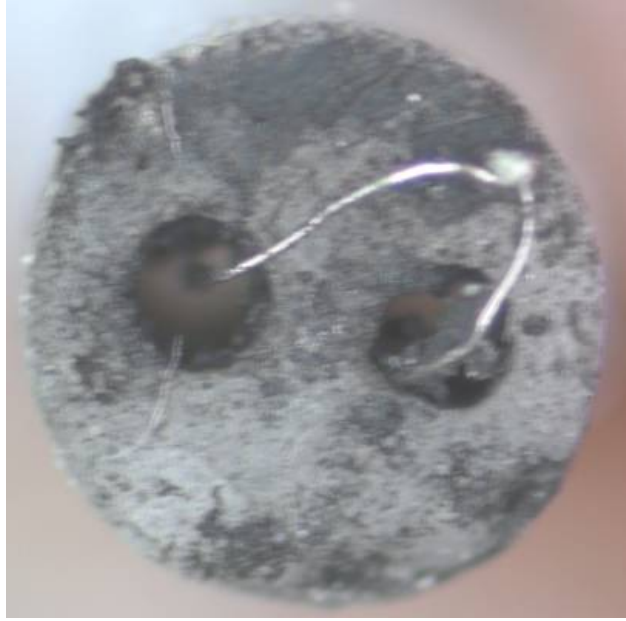
Figure 6. Photograph of 1-mil thermocouple junction mounted with ceramic tube after venting event.

As can be seen in figures 6 and 7, it is possible that the junction of even the 1-mil and the 2-mil thermocouple wires can survive the venting event when mounted with the two-holed ceramic tube. The voltages from the thermocouple were processed through a miniature ice point and recorded on the digital oscilloscope. Correction was made for radiation cooling (11–13) and results for the M129 primers are plotted in figure 8. The similar temperature results for the M125 primer are plotted in figure 9.

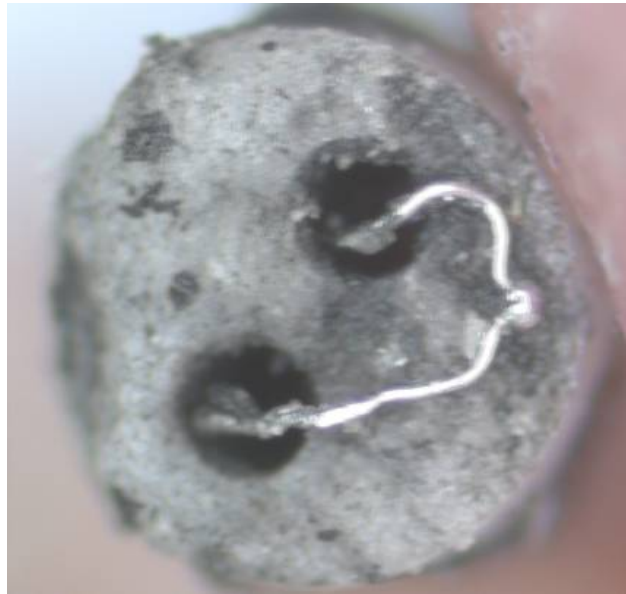
Figure 7. Photograph of 2-mil thermocouple junction mounted with ceramic tube after venting event.

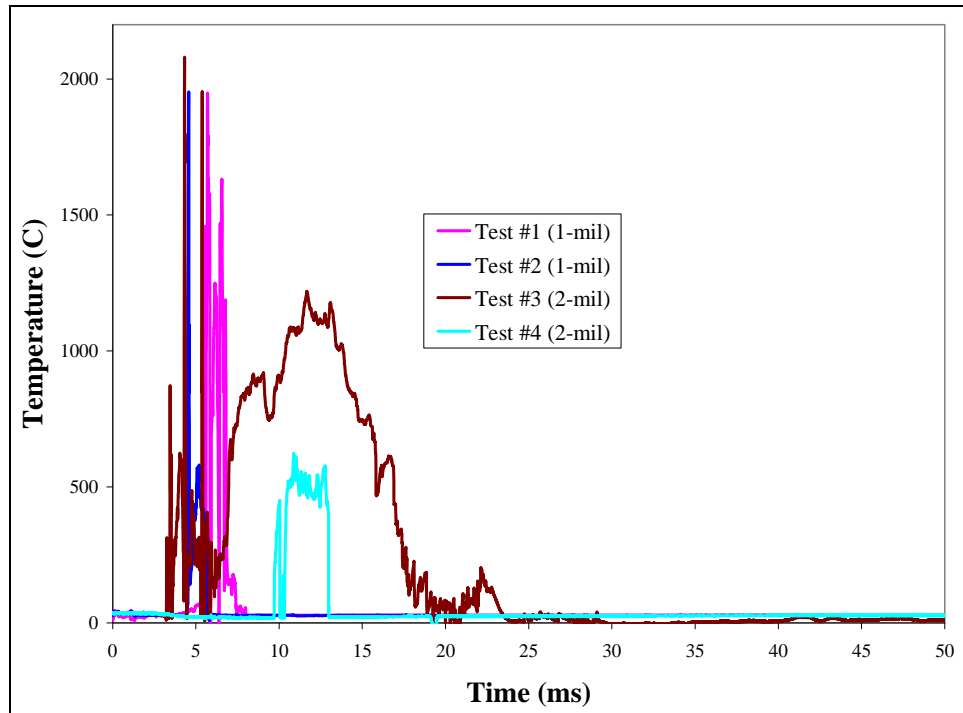
Figure 8. Temperature-time histories recorded for M129 primer.

As shown in figure 8, the similarity from shot-to-shot with regards to temperature was not too good (it will be shown later in the high-speed video that the opening and venting of the pattern of vent holes was not as uniform as desired). However, there were some similarities from shot to shot. The temperatures increased after the pressure began building in the primer and the temperatures decreased at lower pressures. The rapid fluctuations at the beginning of the temperature increase appeared to be real and to correlate somewhat with the timing of shock structures (regions of intense light emissions) in the expanding jet that was evidenced in the high-speed video.

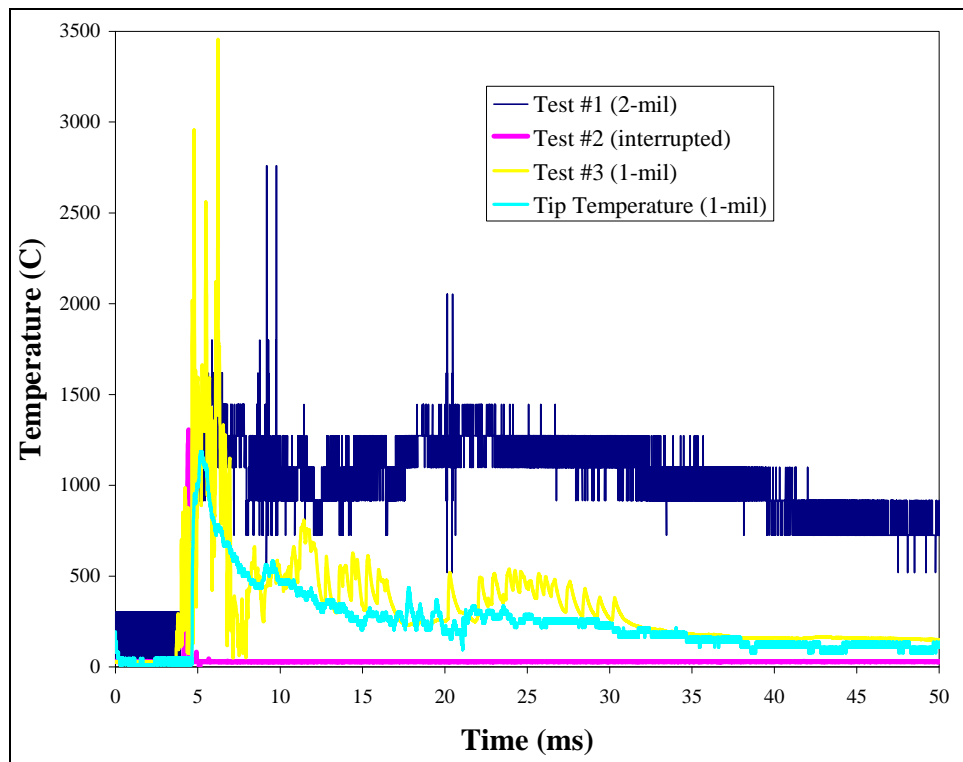
Figure 9. Temperature-time histories recorded for M125 primer.

These same fluctuations also were noted for the M125 primer (see figure 9). However, the hole size in the M125 (nominal 4 mm in diameter) was bigger than the hole size in the M129 (nominal 3 mm in diameter). Therefore, the supersonic flow from the M125 vent hole would exhibit a lower Mach number and a potentially shorter and weaker shock structure than for the M129 (this trend was evidenced in the high-speed video).

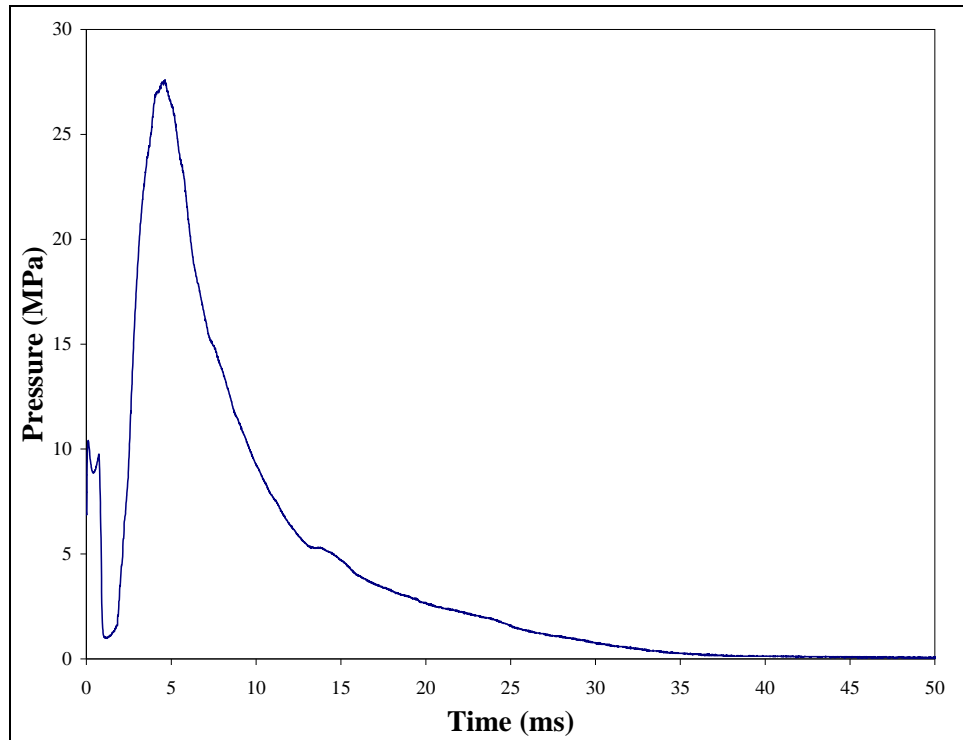
Figure 10. Early pressure-time history obtained for the M129 primer.

Early pressure measurements of the M129 primer with only a rubber gasket around the sealed vent hole resembled the typical pressure-time history as shown in figure 10. The early pressure peak was assumed to be from the headstock initiating since it occurred at the appropriate time and the strength of the headstock initiation was previously unknown. However, in later measurements (in this study) the dynamic electrical parameters of the bridgewire in the headstock also were measured (figure 11). Upon comparison of the firing current and the early pressure peak, the two traces were very similar in shape and timing. It was therefore assumed that a voltage leakage or ground loop problem existed between the bridgewire (firing supply) power supply and the pressure gauge (with associated electronics). The fiber-type gasket material was then placed completely around the entire circumference of the M129 primer tube (with proper placement for the two remaining vent holes at that particular axial position). Once the fiber was in place, electrical contact between the primer tube and the clamp holding the pressure gauge was broken. At this point, the alleged pressure peak disappeared.

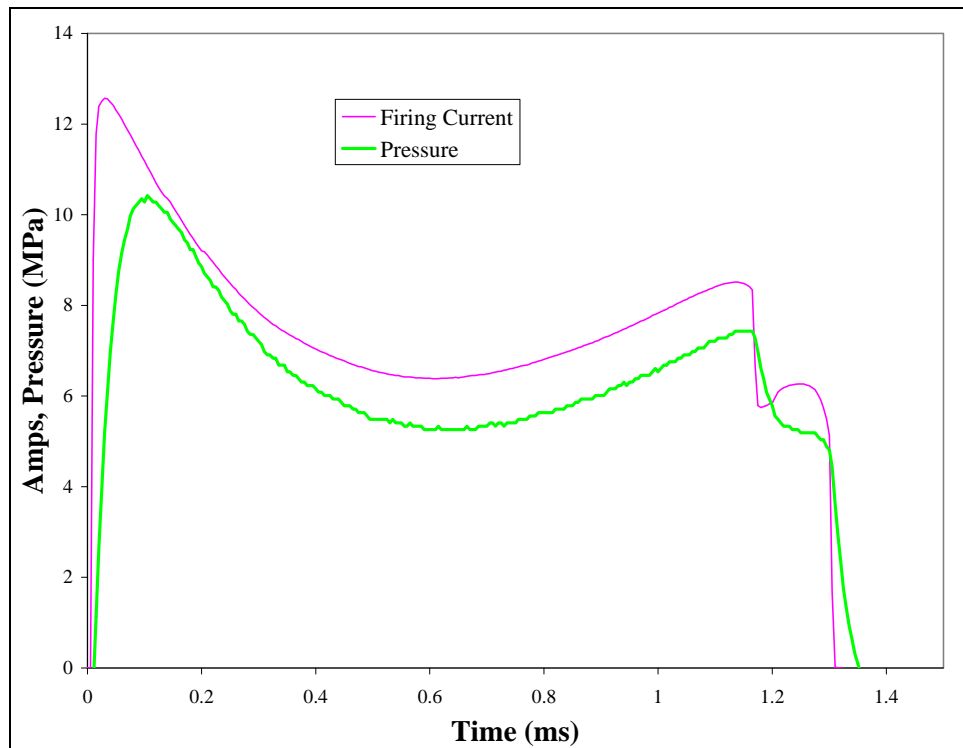
Figure 11. Comparison of firing current trace and early peak in pressure-time history of an M129 primer from figure 10.

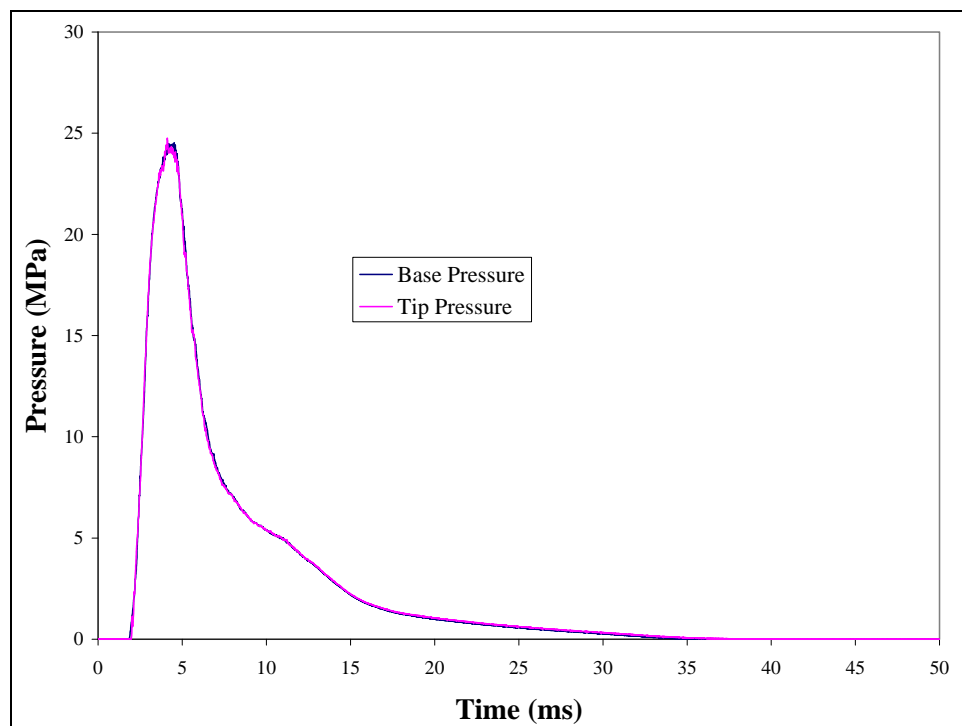
Figure 12. Average pressure-time history produced in the M129 primer (three tests).

Figures 12 and 13 show the average pressure-time histories (averaged over three primer tests) for each primer (the M129 and M125, respectively). The first difference noted was the lack of pressure oscillations in the histories for the M129 and their presence for the M125. The M125 is considerably longer than the M129 and pressure differences (active pressure waves) between the base and the tip could be more easily created (*1*).

The maximum pressure of the M129 primer occurred slightly earlier than that of the M125 (4.35 vs. 4.5 ms) and the base and tip pressures more closely tracked one another. The maximum pressure produced in the M129 was 24.3 MPa and was 25.2 MPa in the M125. It was originally assumed that since the M129 had fewer holes than the M125, and that since the holes had a smaller diameter, that the pressure would be higher. It would appear that the complicated arrangement of a higher loading density in the M129 as related to that of the M125 (1.6 vs. 1.3 g/cm) and increased number of holes per unit length (1.5 vs. 0.9 holes per cm) allowed the pressures to vent as they did. The high-pressure venting of the M129 was slower than that of the M125. The high-pressure full-width-half-maximum of the of the pressure-time histories was 3.4 vs. 2.5 ms. It has been noted in plasma-ignited gun simulators (*14*) that a longer venting time for the primer gases could lead to increased ignitability (propellant bed dependant). This effect could be useful for harder-to-ignite ammunition.

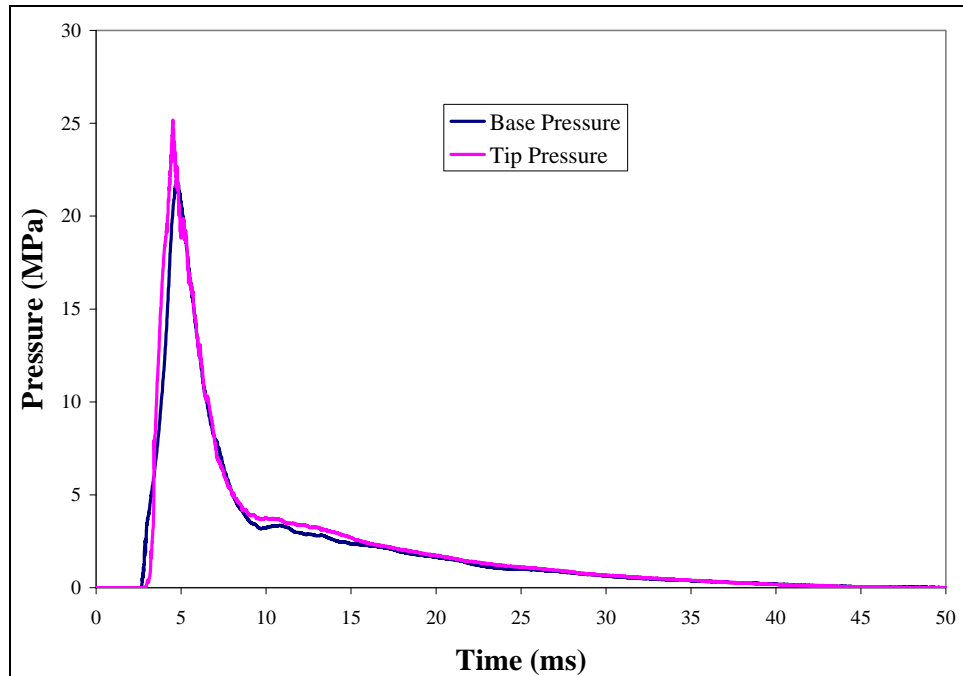
Figure 13. Average pressure-time history produced in the M125 primer (three tests).

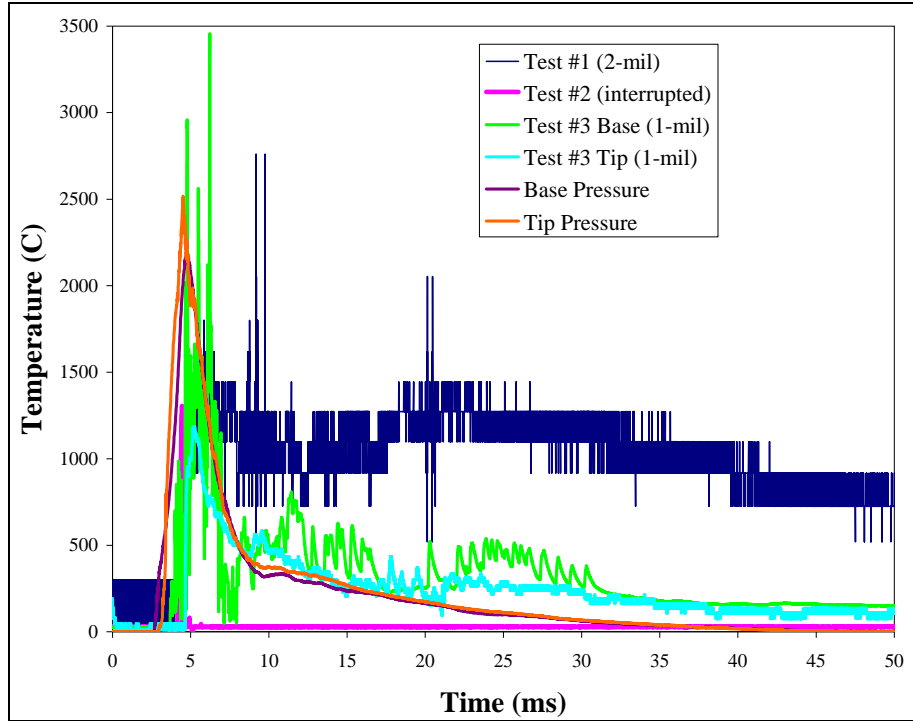
Figure 14. Pressure-time histories produced by the M125 primer in figure 13 compared to temperature-time histories in figure 9.

The use of the ceramic support allowed the use of 1- and 2-mil thermocouples that would usually survive the entire venting. As shown in figures 14 and 15, the smaller thermocouples follow the pressurization/depressurization more closely than the larger thermocouple and show that the fluctuations in the early venting were very narrow in time and approach the temperatures that could be expected in the supersonic expansion shock structure (15). Equilibrium (longer duration) measurements were somewhat lower than the theoretical benite flame temperature (2518 C, obtained from an adiabatic flame temperature calculation). These lowered temperatures were also reflective of various heat loss mechanisms as the gases vented (such as heat loss to the metal primer tube, radiative heat losses, and temperature drop due to high-pressure/high-velocity expansion of venting gases). Initial delay in the temperature rise from the onset of pressurization should also have included the delay that escaping ambient temperature gases from the primer tube in advance of the flame-heated gases would have created.

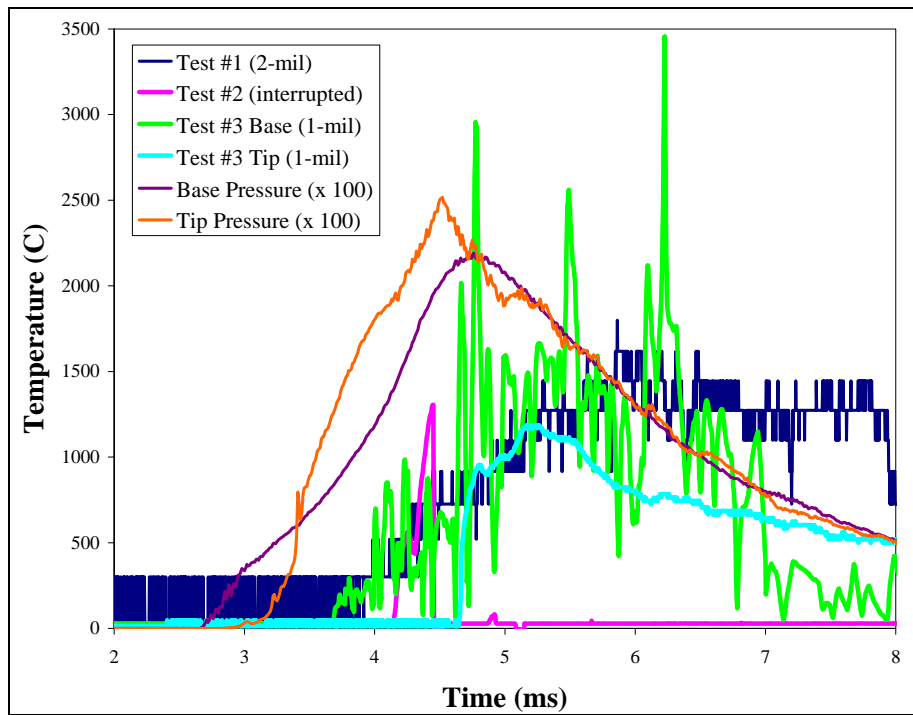
Figure 15. Close-up of pressure-time history and temperature-time history produced by the M125 primer in figure 14 showing delays in temperature rise relative to onset of pressurization.

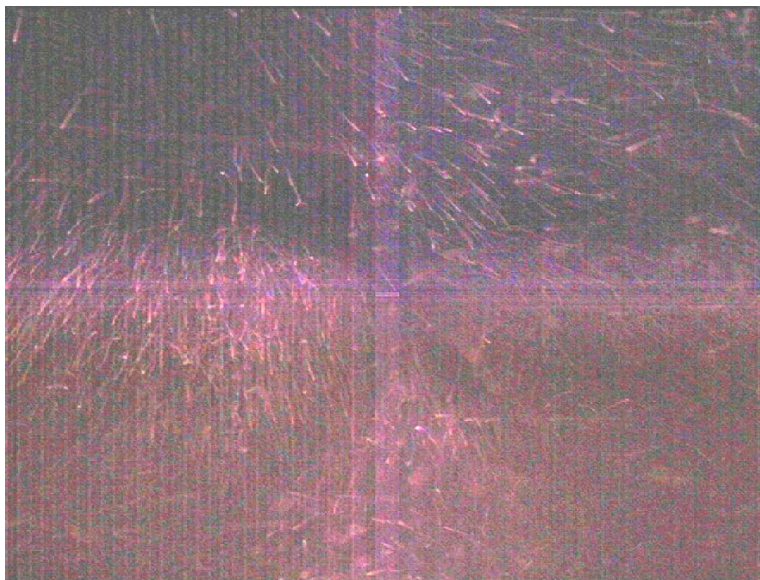
Figure 16. Photograph of end view of M125 firing during low-pressure venting showing glowing particles.

It was noted that a much longer low-pressure venting occurred after the high-pressure venting in both primers. It was assumed that this effect was, in part, due to firing the primer in open air and not within a ballistic simulator where the venting gases would be trapped and the pressure surrounding the primer would increase, especially when the propellant bed ignited. It was noted in the high-speed video that during this low-pressure venting that the light emissions from the venting gases diminished. The diminished light emissions generally correlated with decreased temperature of the venting gases as reported by the thermocouple. Another important item noticeable during this time was, due to the diminished light emissions, the view of many glowing (possibly burning) particles (for example, the M125 primer in figure 16). Most likely, these particles were present during much of the venting period but visual reporting of their glow was not possible due to the large visible emissions from the hot gases that would mask their presence.

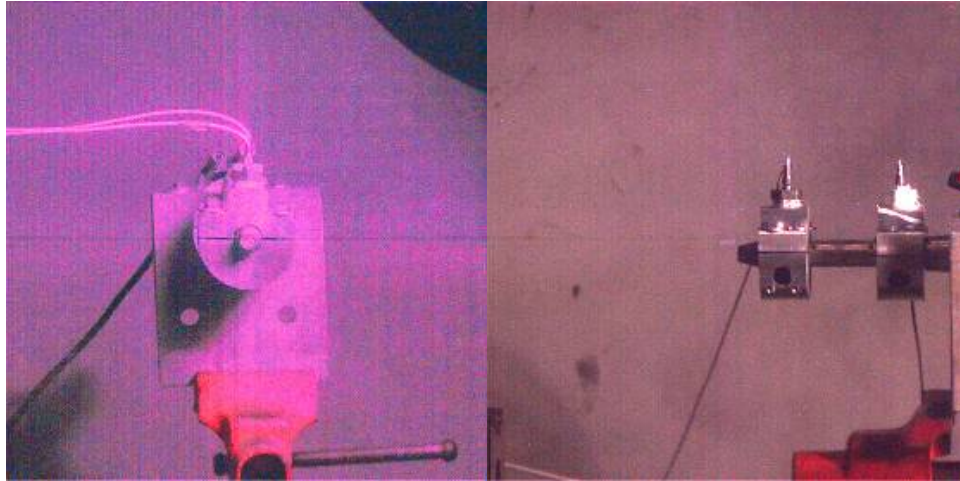
Figure 17. Photographs of M129 primer in firing fixture from tip end (left) and axial (right) views.

High-speed video was taken of each primer looking along the long axis and also looking down that axis from the tip end. Figures 17 and 18 show still photographs prior to firing of the M129 and M125, respectively. The axial view of the M129 firing in figure 19 shows that not all of the vent holes operated at the same time. The first light showed greatest intensity near the bridgewire and then was somewhat evenly distributed over the rest of the primer. The hole-to-hole venting pattern then quickly changed. Venting started near the bridgewire and at the end of the primer with little in between. The tip vents, in particular, showed high pressure venting with detached shocks at a distance from the vent hole. After ~2 ms, the hole-to-hole venting pattern became more erratic with different vent holes showing varying amounts of light and jet structure. At long time (after ~9 ms), and at much lower pressure than maximum (~1/5th of maximum), the

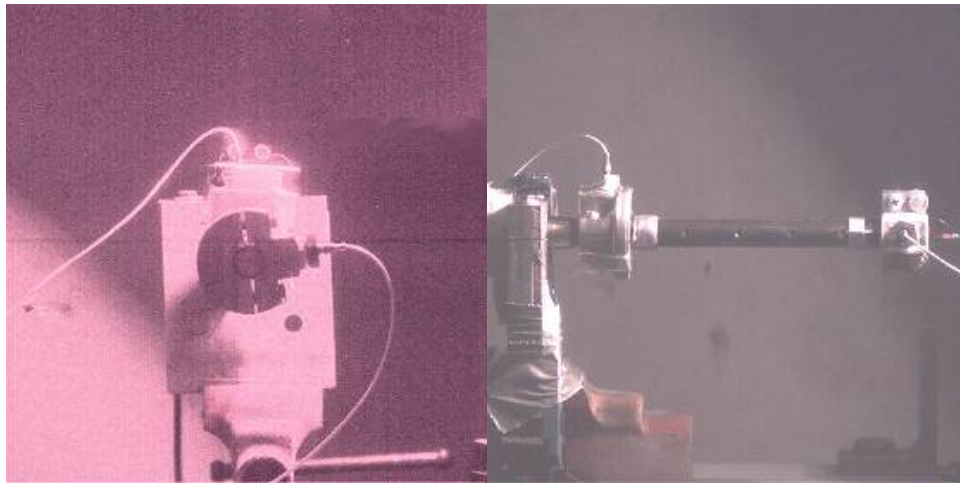
Figure 18. Photographs of M125 primer in firing fixture from tip end (left) and axial (right) views.

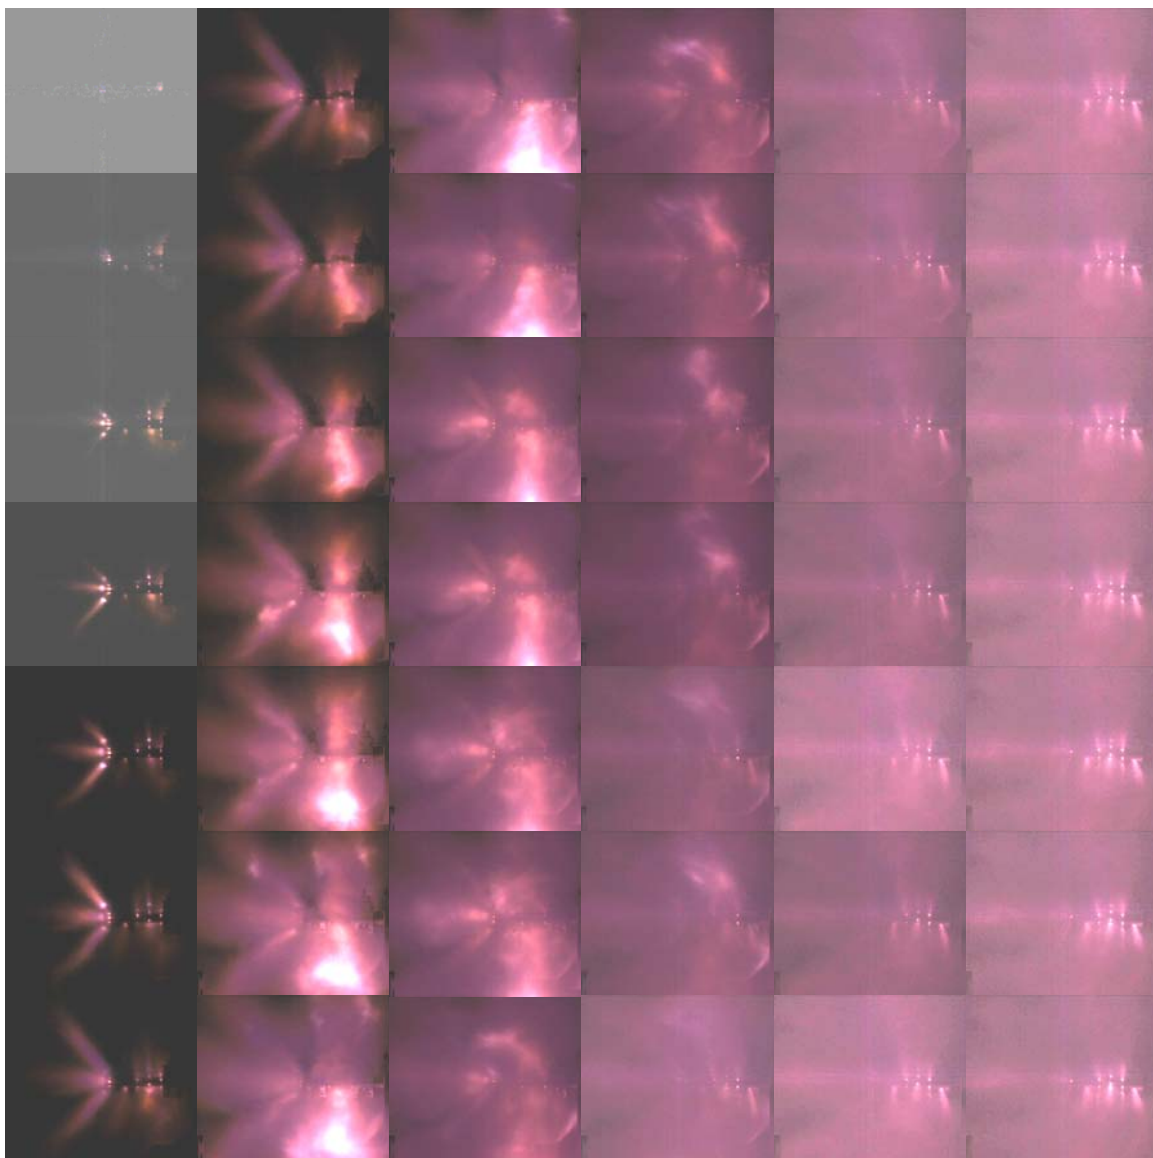
Figure 19. High-speed frames (from top to bottom) of axial view of M129 primer; frame time was 263 μ s.

hole-to-hole venting pattern once again became mostly even. The end view (figure 20) also showed the shock structure from the tip vents (until the jets from the other vent holes had expanded past the radius of the pressure clamp as shown in figure 17, they were not visible). The end view showed that the venting pattern was erratic during the entire venting process with the most active vents changing from frame to frame. Even at low pressure, the erratic hole-to-hole venting (not so obvious in the final frames of the axial view in figure 19) continued.

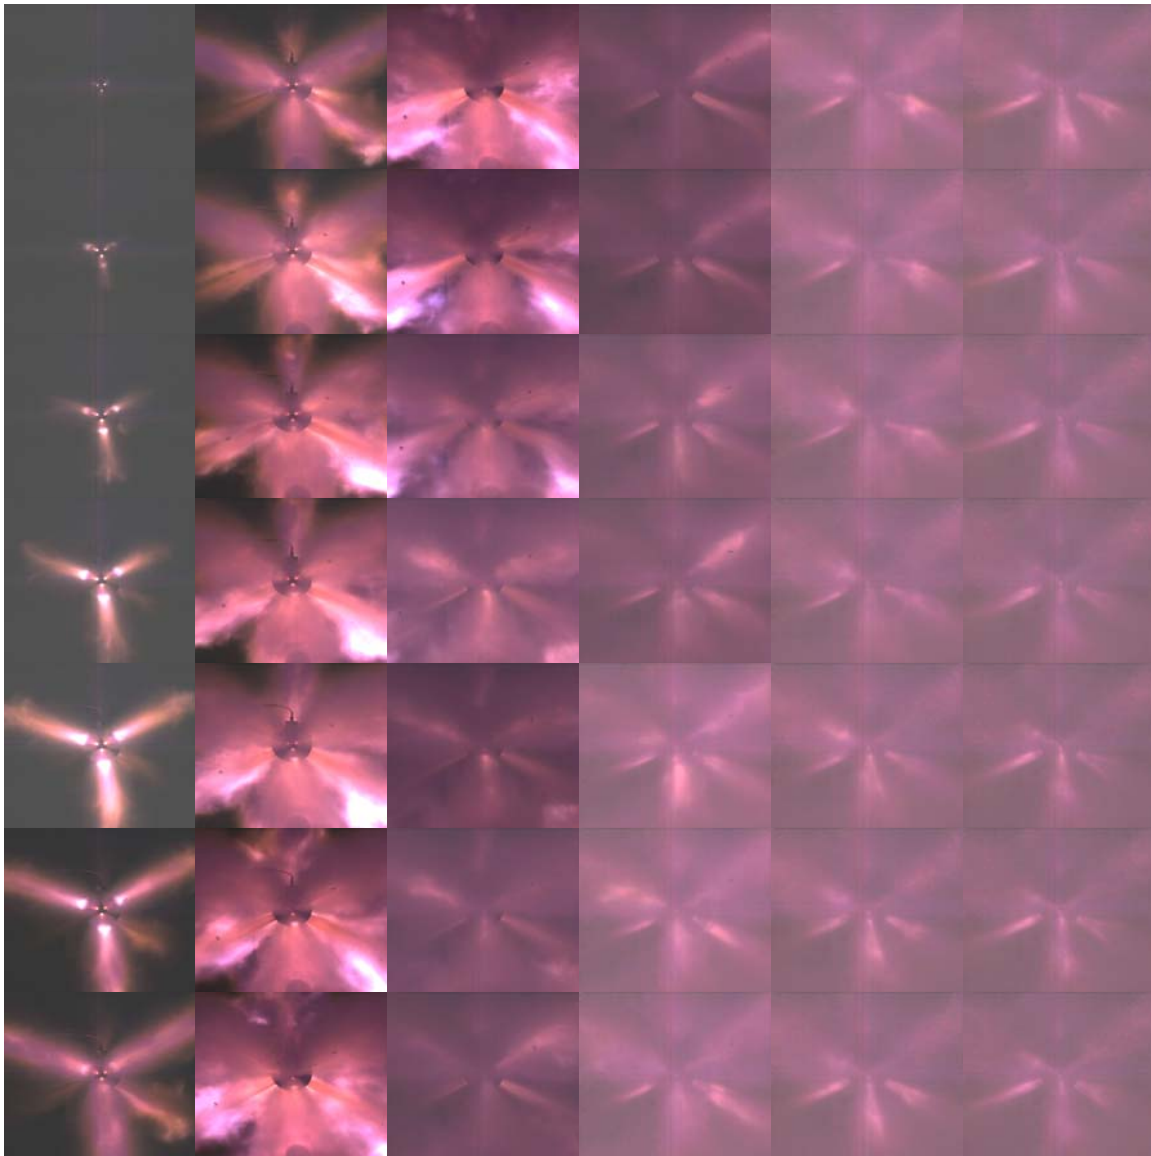
Figure 20. High-speed frames (from top to bottom) of end view of M129 primer; frame time was 263 μ s.

The view of the tip vents of the M129 primer in figure 20 and the axial view of the M125 primer in figure 21 clearly showed that the benite was not totally consumed within the confines of the primer body. Dark chunks that looked like pieces of benite were seen in the jet flows during the approximate interval of 1–5 ms. If they continued to escape the primer body after this interval, the background illumination from the expanding jets was not sufficient to allow detection. After firing, small pieces of benite were found on the table under the primer as well as across the room (see figure 22). It is unknown from which primer each piece of benite originated since the pieces were not found until experimental series had finished. However, the long piece in the photograph was ~2 cm in length. It was assumed that the only manner by which it could have escaped the primer tube was through the vents on the tip of the M129 primer since the tip vents were aligned axially as was the original benite rods.

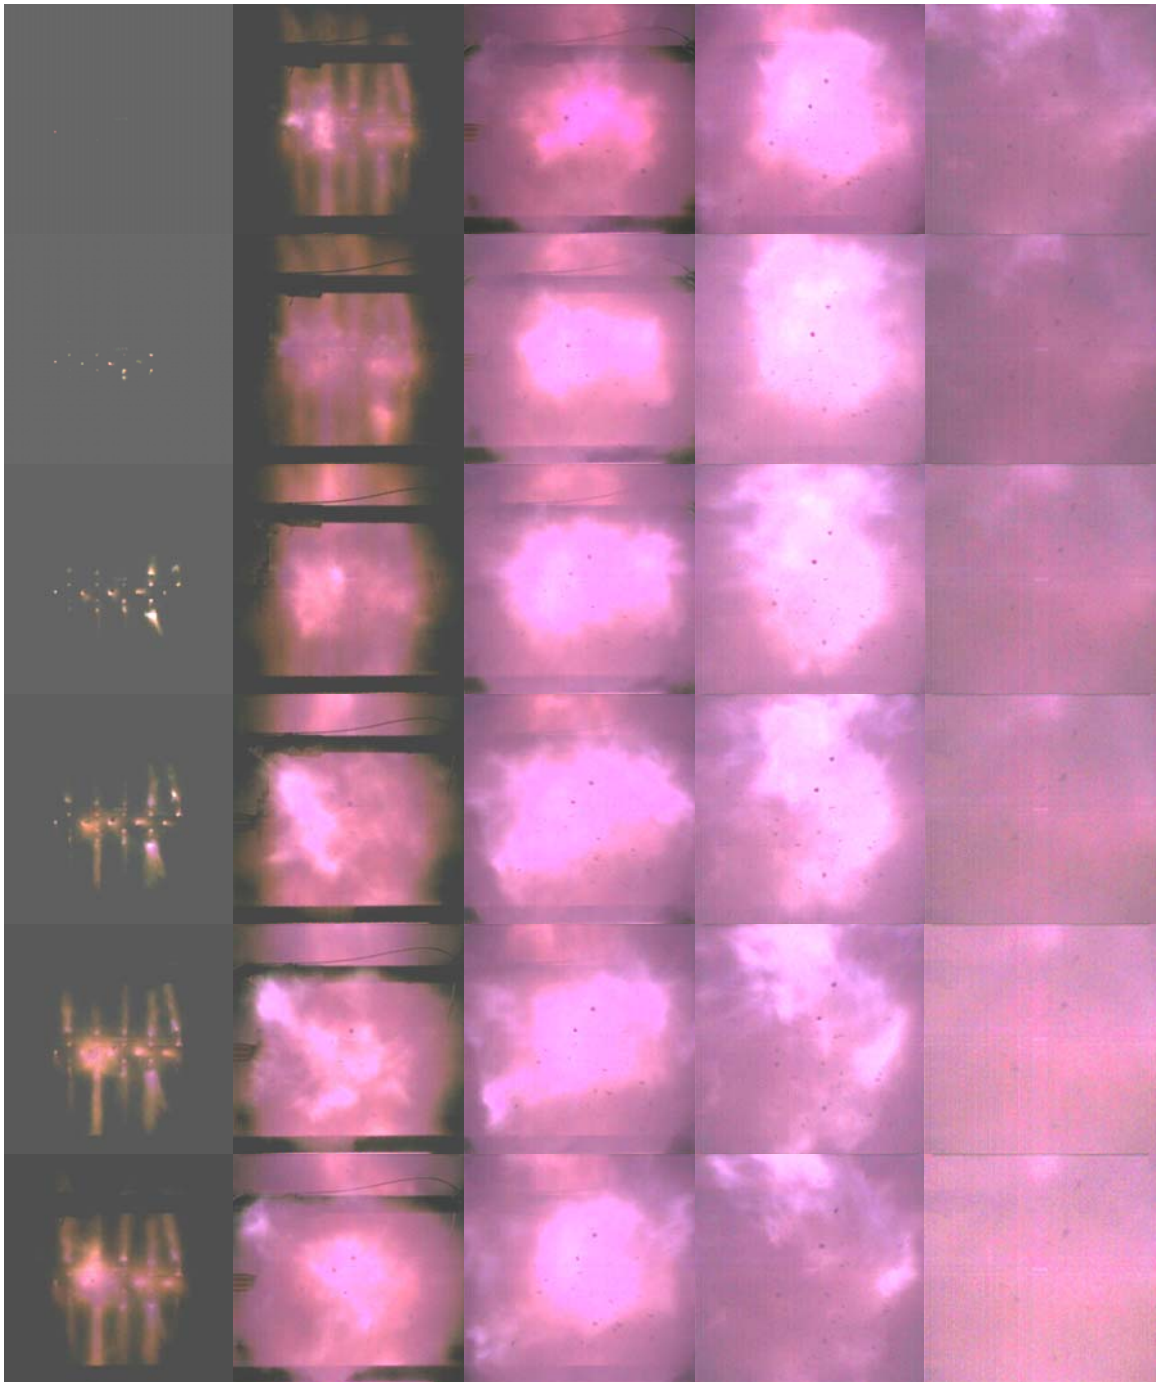
Figure 21. High-speed frames (from top to bottom) of axial view of M125 primer; frame time was 263 μ s.

The findings on the high-speed video for the M125 are shown in figures 21 and 23. Both the unevenness in hole-to-hole venting and the relatively large solid objects in the venting jets show quite readily. For particular integrated ammunitions, these attributes must be taken into account in order to design the optimal performance or remove safety concerns.

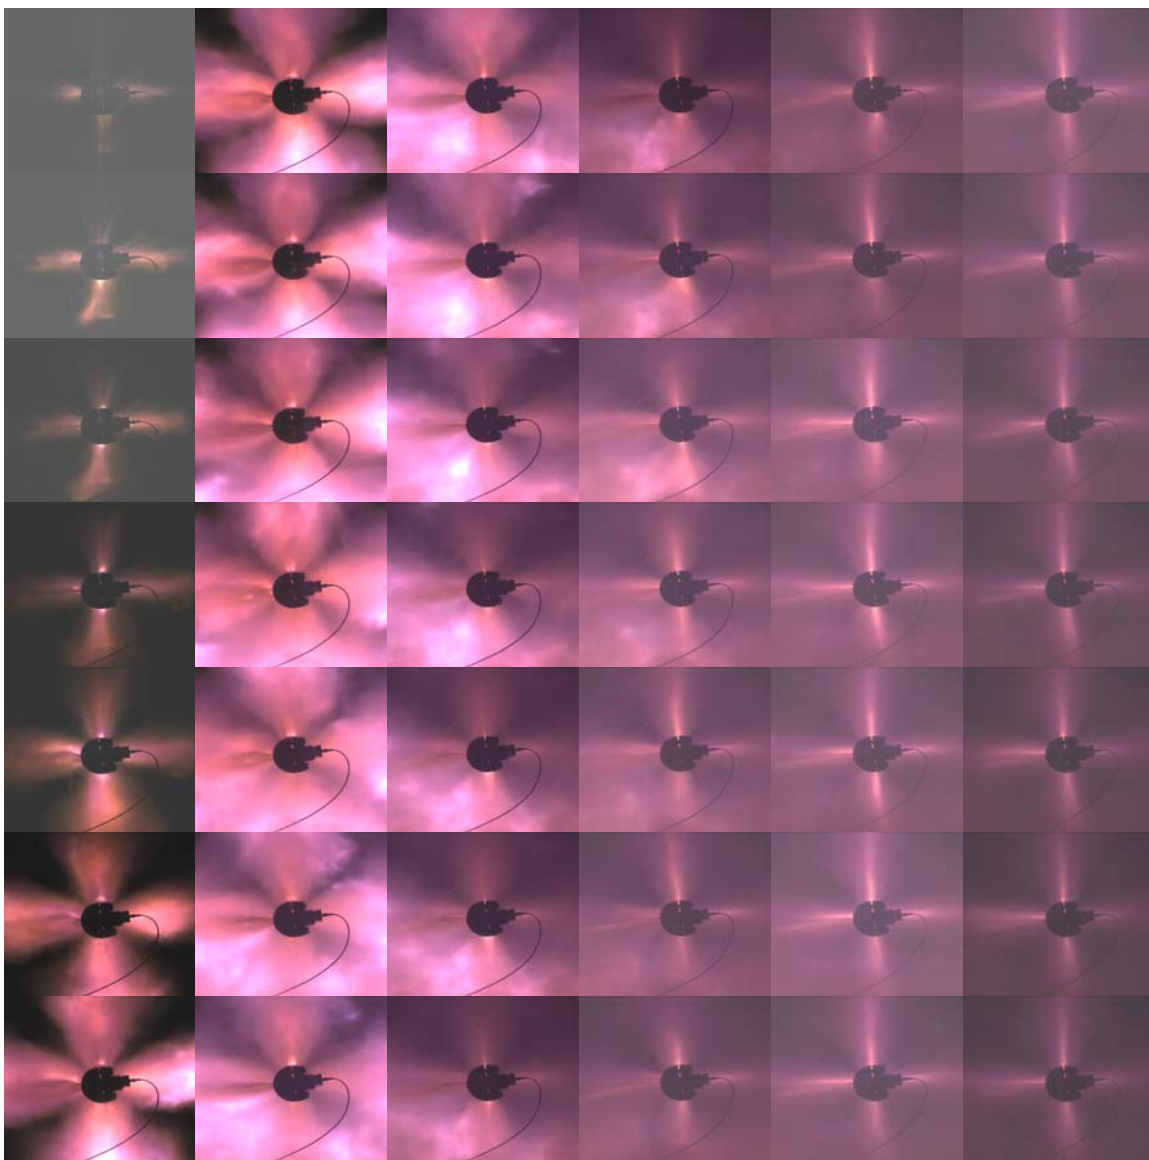
Figure 23. High-speed frames (from top to bottom) of end view of M125 primer; frame time was 263 μ s.
